Excavation and survey of the Ara Metua (*Ara Nui o Toi*) and related sites at Arai te Tonga

Preliminary Report June 2019

Cook Islands Tangible Cultural Heritage (CITCH) 2019 Report 3

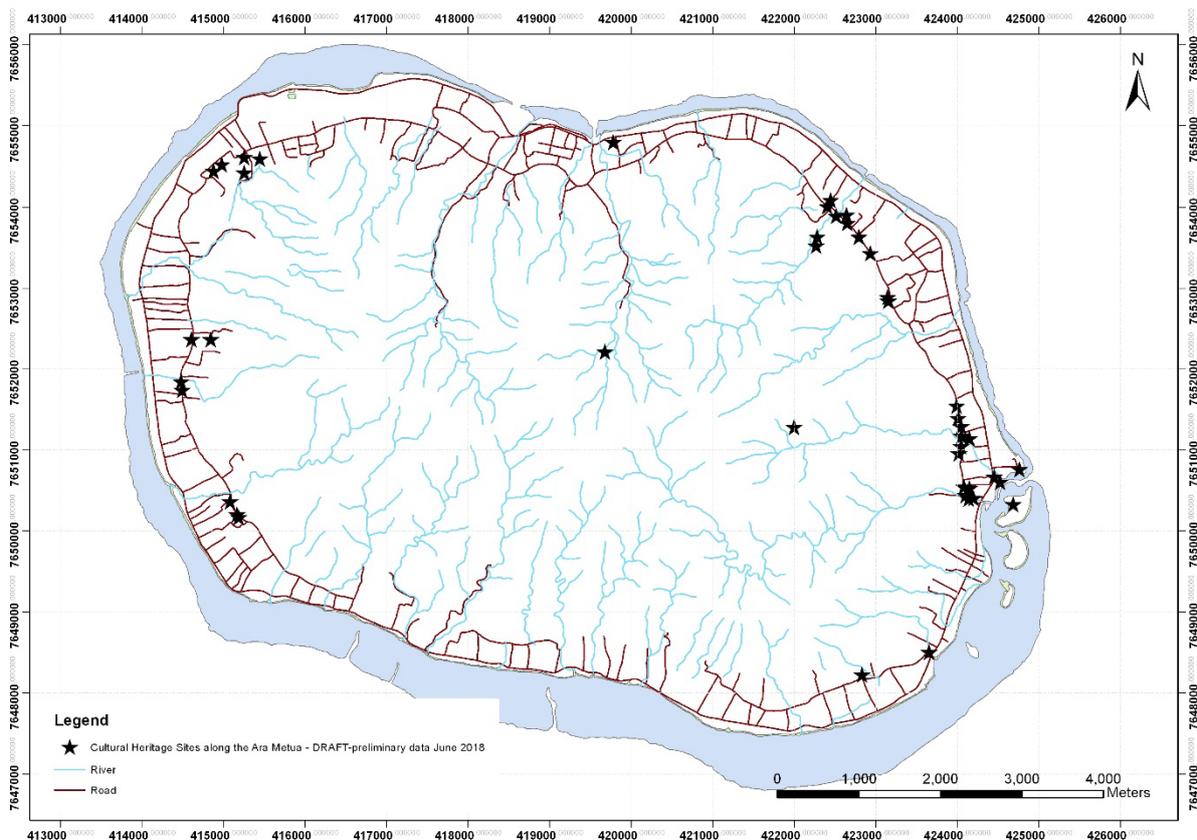
Figure 1. The circuit of the Ara Metua in Rarotonga (stars mark the previously-recorded associated sites and stretches of extant kerbing).

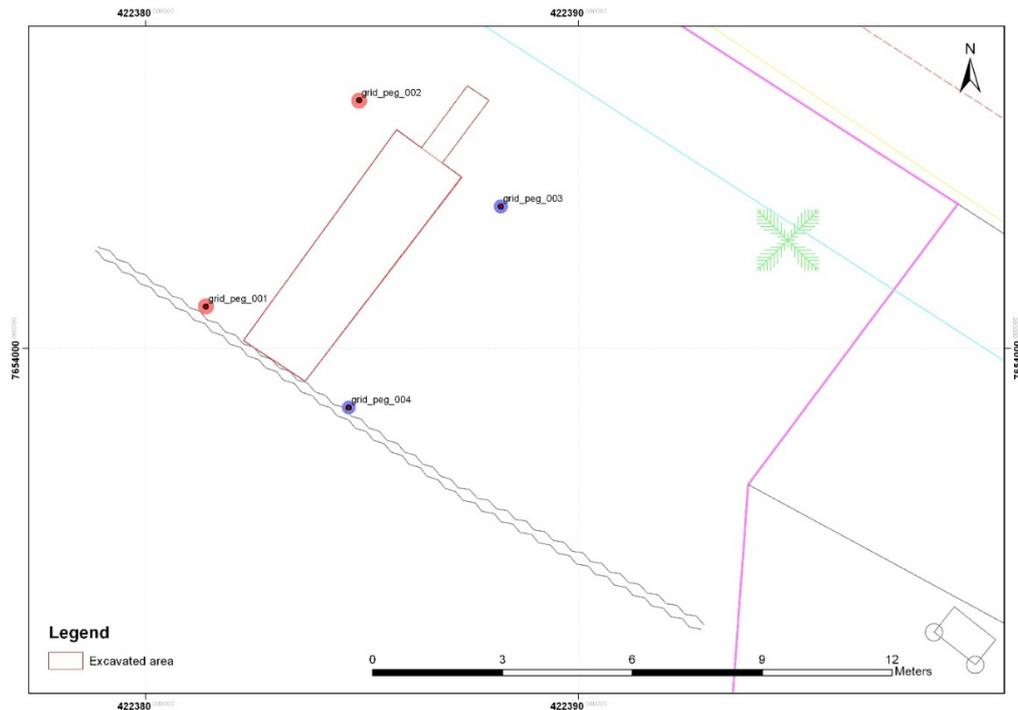
In 2018 a 2m x 6m trench was excavated across the Ara Metua (Fig. 2), slightly to the west of Arai te Tonga (see report for 2018). The stratigraphy revealed the presence of three superimposed road surfaces.

Figure 2. Location of the 2018-19 excavation trench at Arai te Tonga.

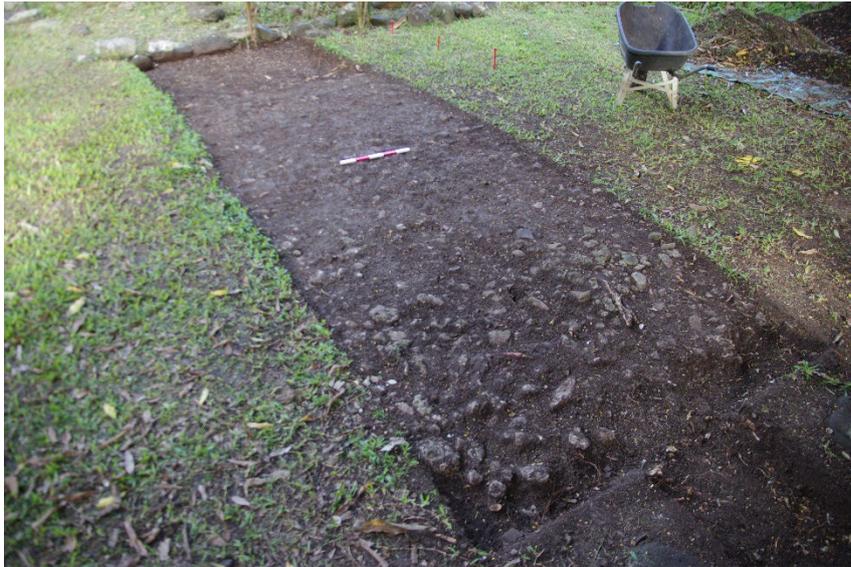
In its final form, the road was c. 4m wide and surfaced by a hard and compressed combination of basalt and coral lumps. This hard final road surface can be attributed to the requirements of greater traffic, particularly the introduction of motorised vehicles in the 1950s and 1960s (Fig. 3).

Figure 3. The upper metallated surface of the Ara Metua at Arai te Tonga.

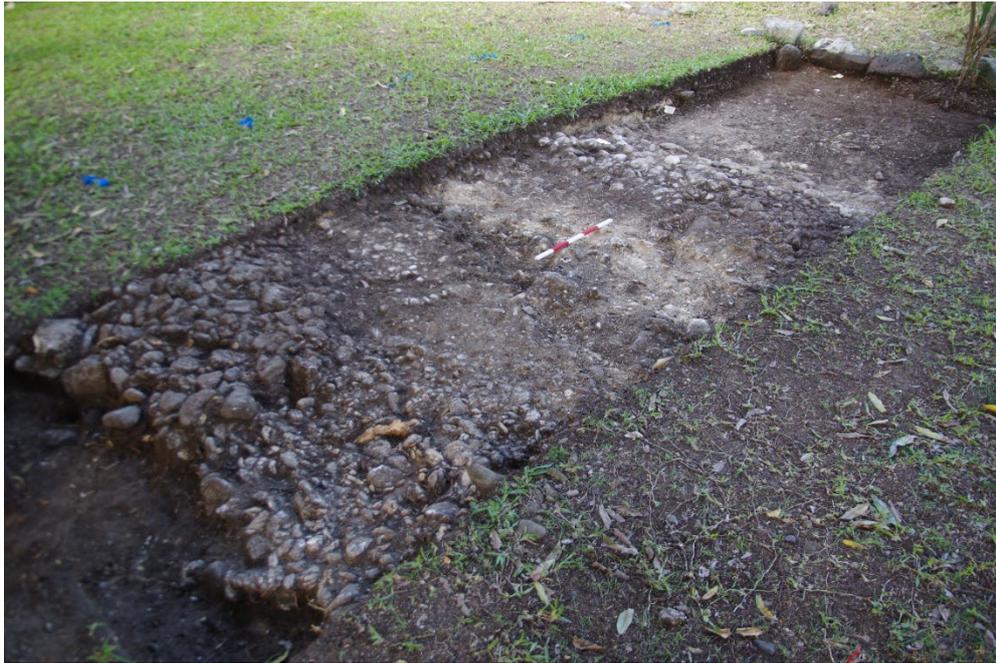
Beneath this an earlier road was revealed as represented by the thick foundation/make-up deposit [024]. This served to elevate the road and emphasise its hard packed surface of coral pebbles and blocks (Fig. 4). Certainly, as it passed Arai te Tonga, the Ara Metua appears to have been kerbed along its northern edge by basalt uprights, of which unfortunately only a single example was found *in situ*. In this form the Ara Metua must have been a truly spectacular construction displaying a white coral surface with black basalt kerbing. It is almost certainly this phase of the Ara Metua that was seen and described by Percy Smith (1903) in the 1890s, and Te Rangi Hiroa in the 1920s. As revealed by excavation, this surface had suffered considerable wear which indicates a relatively long life, consequently we can be confident that it stood in this form over a substantial period of time, and may have been quite old when seen by Smith in the 1890s. Judging from the photograph taken by Buck in the 1920s, the road surface at the adjacent *marae* of ‘Are Rangi, had become covered by soil (see Fig. 6).

Figure 4. Secondary rammed coral road surface of the Ara Metua, which was probably that seen by S. Percy Smith in 1898.

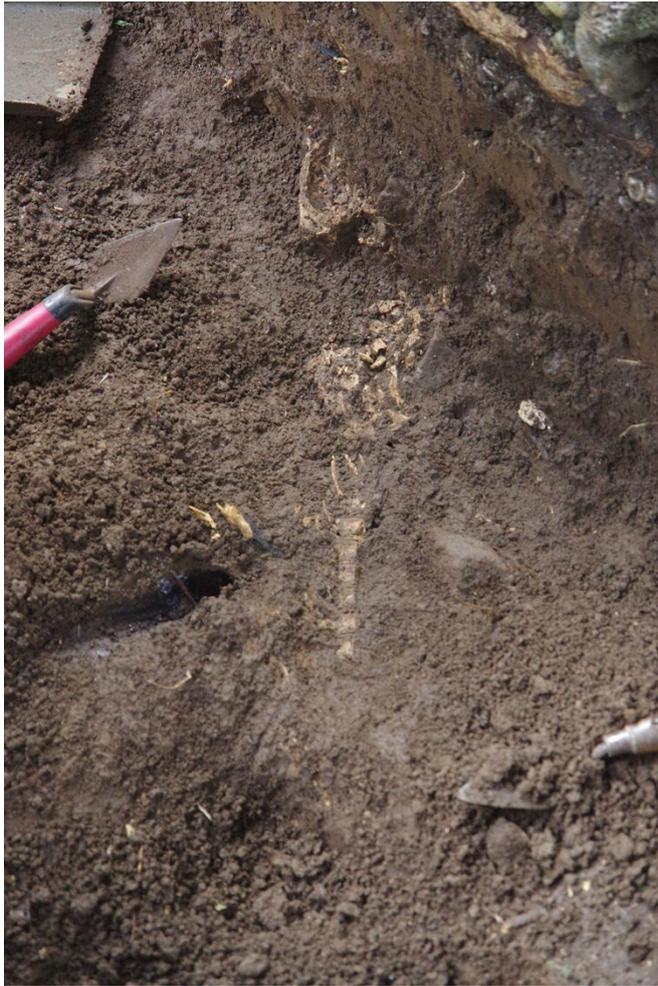
The 2019 fieldwork examined the deposits beneath the earliest road surface [026]. The deposit [036] was excavated to a depth of c. 90cm, its constitution was fairly homogenous being of silty texture and red-brown in colour (a micromorphological soil column for subsequent analysis was taken). However, the upper soil profile contained charcoal flecks and fragments demonstrating anthropogenic activity. Consequently, activities involving burning had already occurred before the Ara Metua was built (see next section). At a depth of c. 25cm (Spit 5 of [036]) the skeleton of an animal, was encountered (Fig. 5). Beyond a depth of c. 55cm the charcoal flecking ceased and the soil profile appeared to become ‘sterile’.

Figure 5. The animal skeleton in deposit [036].

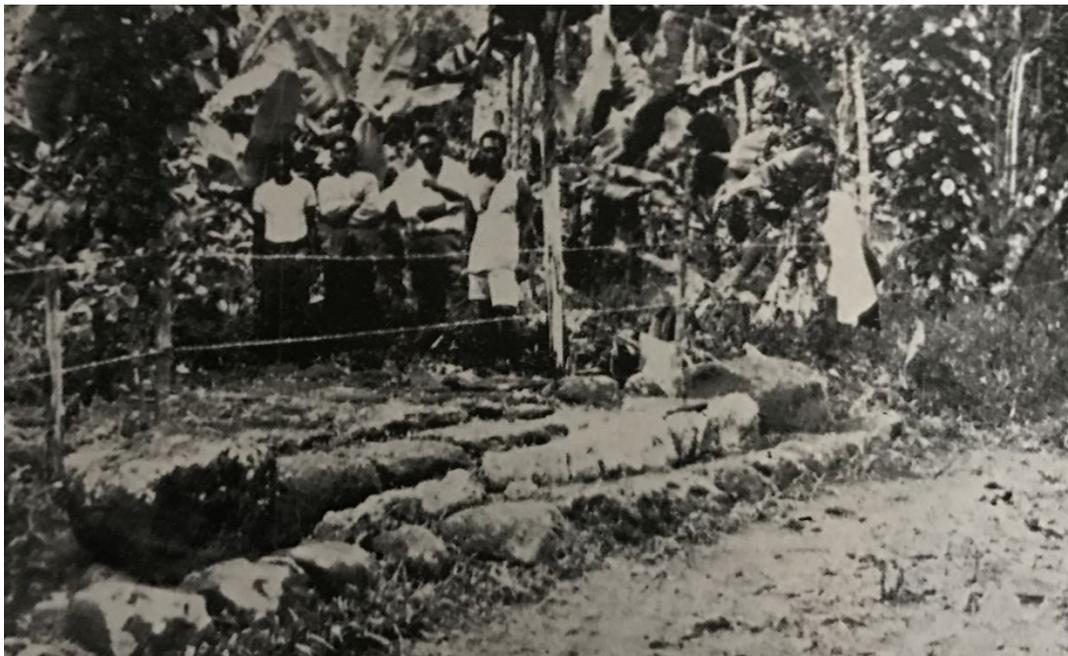
In the foreground is the curb of the Great Road [Te Ara-nui-o-Toi, or the Great Road of To'i, the Ara Metua], which makes a step. The back of this is lined with coral slabs, toka-a-punga. Behind that again is the surface of the branch road which leads back to the house known as Harerangi. On the left and right are large stones used as seats.

Unless the site had been considerably re-worked between Smith's and Hiroa's visits (which seems unlikely), Hiroa's description is more accurate and accords with the site as it is currently visible (Fig. 6).

Figure 6. Paepae 'Are Rangi where it fronted the Ara Metua in 1926 (Hiroa 1927, Figure 185).

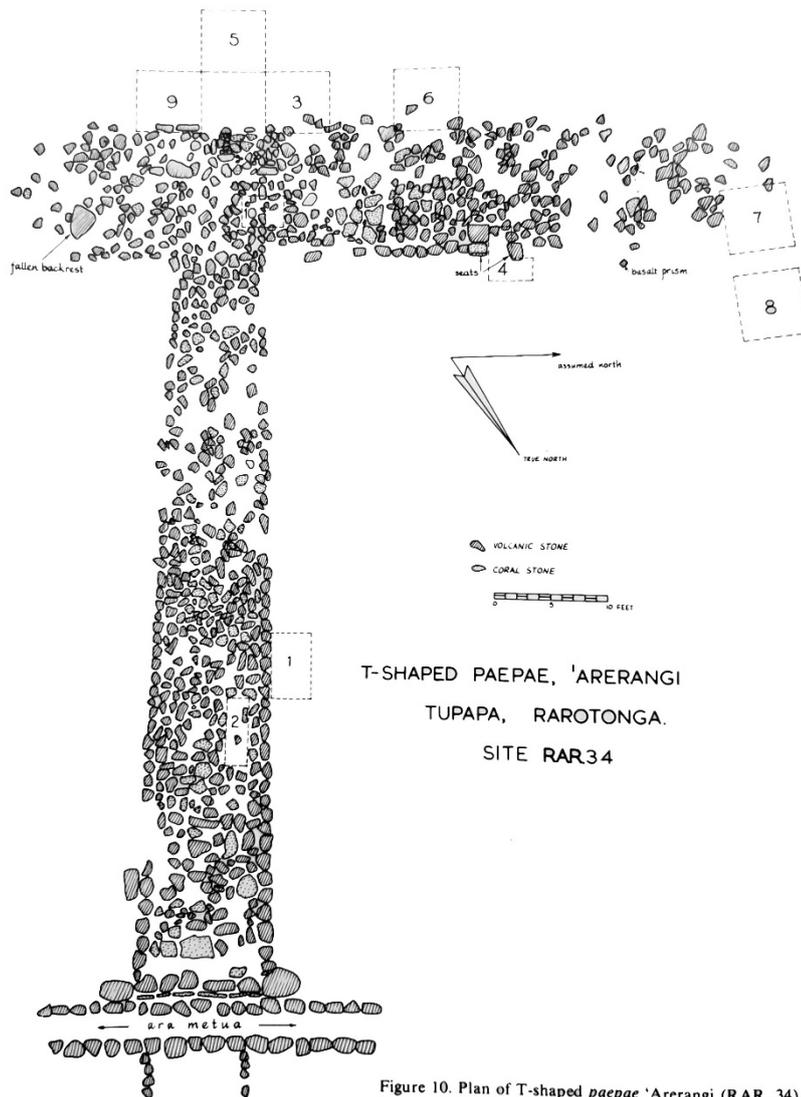
They noted that the platform at the rear of the path, that forms the cross of the “T”, was largely incomplete but may have measured as wide as 19.5 m. They mapped the site quite carefully (Fig. 7) and opened up ten excavation trenches across and adjacent to the paepae, mostly 6 x 6 feet. The description of the investigations is quite short and in places unclear, but suggests that the rear platform at least was a historic period construction, or reconstruction, as burnt coral lime, a post-missionary introduction, was found beneath the paving. Large, deep postholes that were interpreted as having originally contained posts about 25 cm in diameter that had been removed by digging a hole next them. These postholes were filled with blocks of burnt coral lime. The path from the road to the platform (the stem of the “T”) overlay a charcoal soil layer (though disturbed by pig rooting) that was interpreted as being the same as Layer 8 from the adjacent ‘Are Kariei excavations (Wilkes 1974, 49-50, Figure 14, not further discussed in this report), so that ‘Are Rangi postdates the ‘Are Kariei in construction. The path was interpreted as being constructed earlier than the platform (Wilkes 1974, 52).

Figure 10. Plan of T-shaped *paepae* 'Arerangi (RAR. 34).

Figure 7. The Canterbury Museum plan of 'Are Rangi. (Duff and Duff 1974, Figure 10).

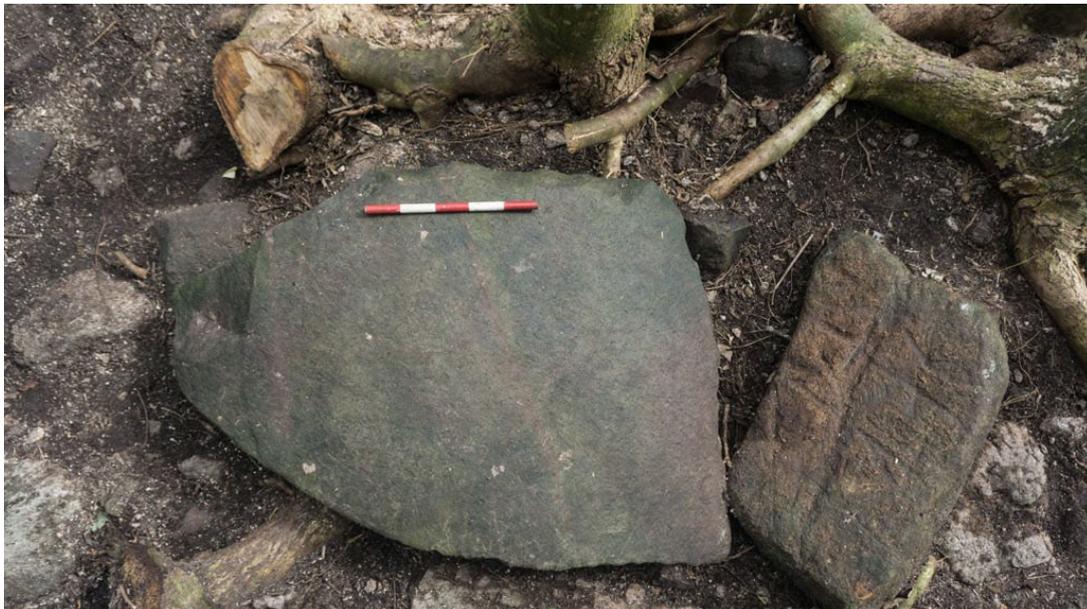
A seat with a coral back and dished basalt seat remains *in situ* on the eastern arm of the platform, as described by Duff and Duff (1974: 43). Next to this is another probable seat and several large stones scattered across the surface of the platform may also be fallen seats. Most of the stone on both the pathway and the platform is a moderately coarse, vesicular dark-grey basalt, which is presumably from a local source, but one piece was observed that was a fine-grained light-grey basalt, with a smooth surface and some evidence of deliberate shaping in the form of flake scars around the edge. This was presumably brought in site from elsewhere on the island.

Figure 8. Fallen seat originally recorded by Duff and Duff (1974: Figure 10) on the now destroyed eastern arm of the platform, now located on the pathway close to the road.

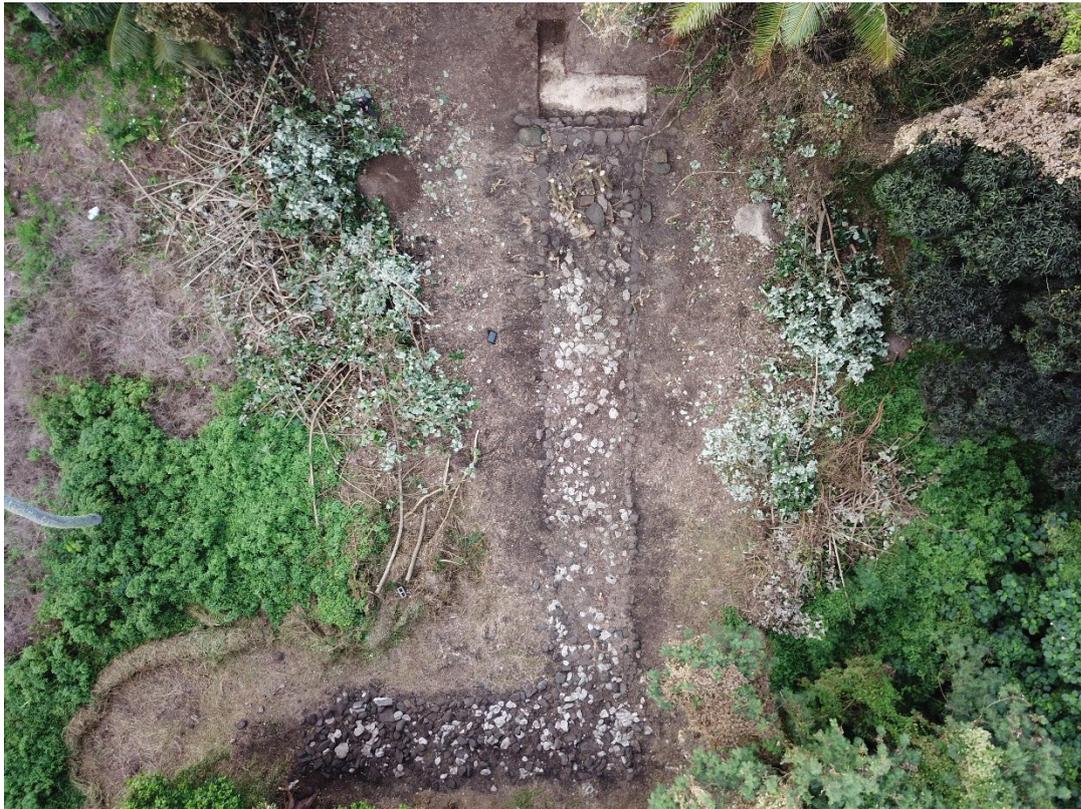
Figure 9. Aerial view of ‘Are Rangi following clearance and excavation.

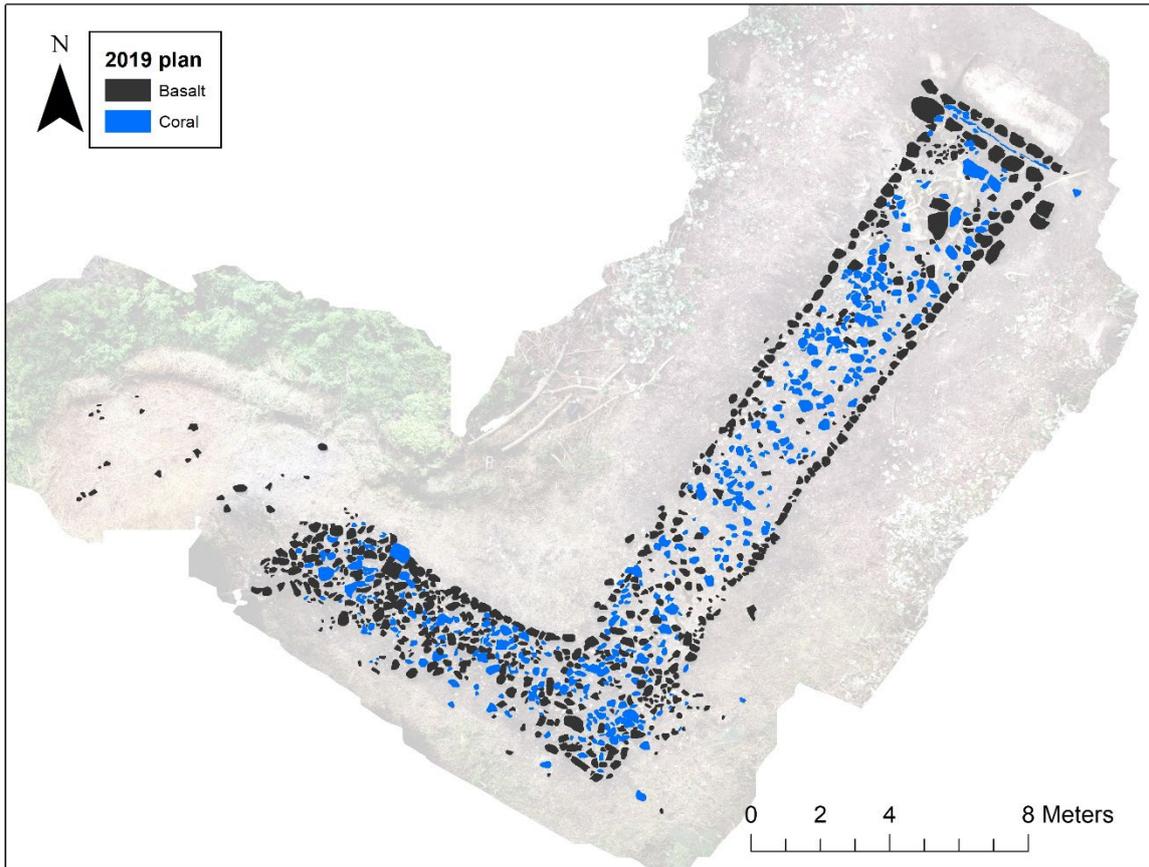
Adjacent to the Ara Metua, the pavement of the pathway is made of more substantial basalt and coral stones that remain *in situ*. A 4 x 4 m excavation trench was opened above the road at the front of the paepae and excavated down as far as the kerbing. This trench was as wide as the front of the paepae and extended across the width of the road to encompass one of the stone lines that joined the ‘Are Kariei to the road (Wilkes 1974, Figure 14).

Figure 10. Plan of ‘Are Rangi (basalt in black – coral in blue).

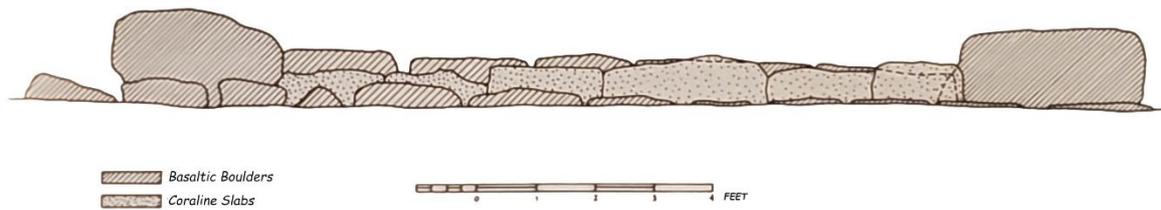
Figure 11. Road side profile of Are Rangi visible in the early 1960s (Duff and Duff 1974, Figure 11).

The front of the paepae (compare Fig’s 11 & 12), where it joins the landward road kerb, remains largely as shown by Hiroa (1927: Figure 185) and Duff and Duff (1974: Figure 11). Within the excavation trench 10 basalt stones forming the landward kerb [104] were exposed, measuring between 0.45 x 0.48m and 0.32 x 0.83m in plan. Tree roots have shifted some of these slightly out of place. Behind the kerb, the first element of the paepae is a line of six shaped coral uprights [105] (Fig. 12). Both Hiroa (1927) and Duff and Duff (1974) show that the western coral uprights are higher than the eastern uprights, and this remains the case. However, the westernmost upright has been disturbed out of position, probably by tree roots. Behind this line of coral uprights is a series of five large, carefully laid basalt paving slabs at the same or slightly higher level as the top of the coral. At either end of this line of basalt was a larger basalt boulder, but only the western boulder remains *in situ* [102] measuring 1m x 0.7 m x 0.35 m above ground level. The eastern boulder [103] has been disturbed and rests out of

position, and is now broken in two. The kerb of the paepae remains *in situ* but much of the paving has been disturbed and displaced.

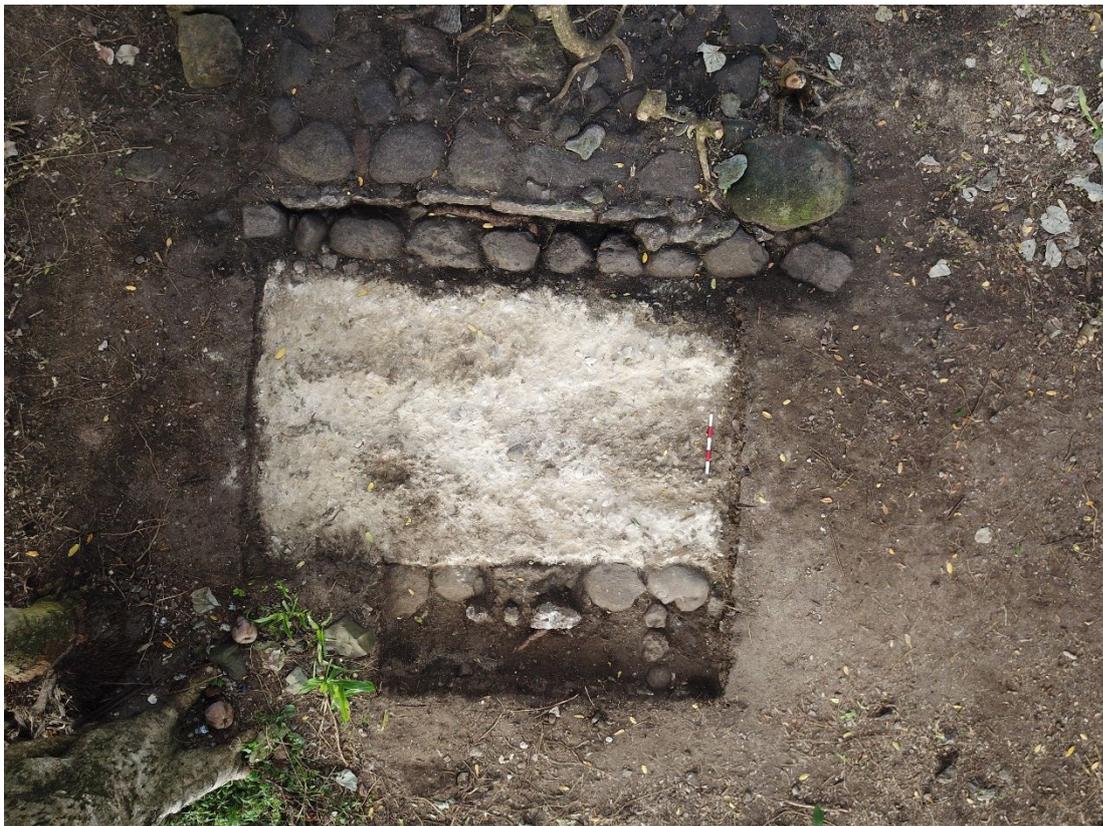
The seaward kerb of the Ara Metua [107] was also exposed beneath the upper deposits where seven aligned basalt kerb stones were uncovered. These ranged in texture from fairly fine-grained to quite blocky basalt. The width of the Ara Metua between the two lines of kerbing was quite narrow in being 2.1m. Percy Smith (1903, 219) described the road at this point as being 16 feet (4.8 m) wide. Hiroa's illustration (1927, Figure 185) does not show the seaward kerb, while Duff and Duff's (1974, Figure 10) plan shows the road as being extremely narrow at this point, approximately 2 feet (0.6 m). These discrepancies are not easily accounted for, although it seems that Duff and Duff have made no attempt at accuracy with regards to the width of the road. Nonetheless, the kerb stones they illustrate are the same as those exposed in 2019 (Fig. 13).

Figure 13. Aerial view of the Ara Metua at 'Are Rangi, note the *in situ* basalt kerbing to both sides.

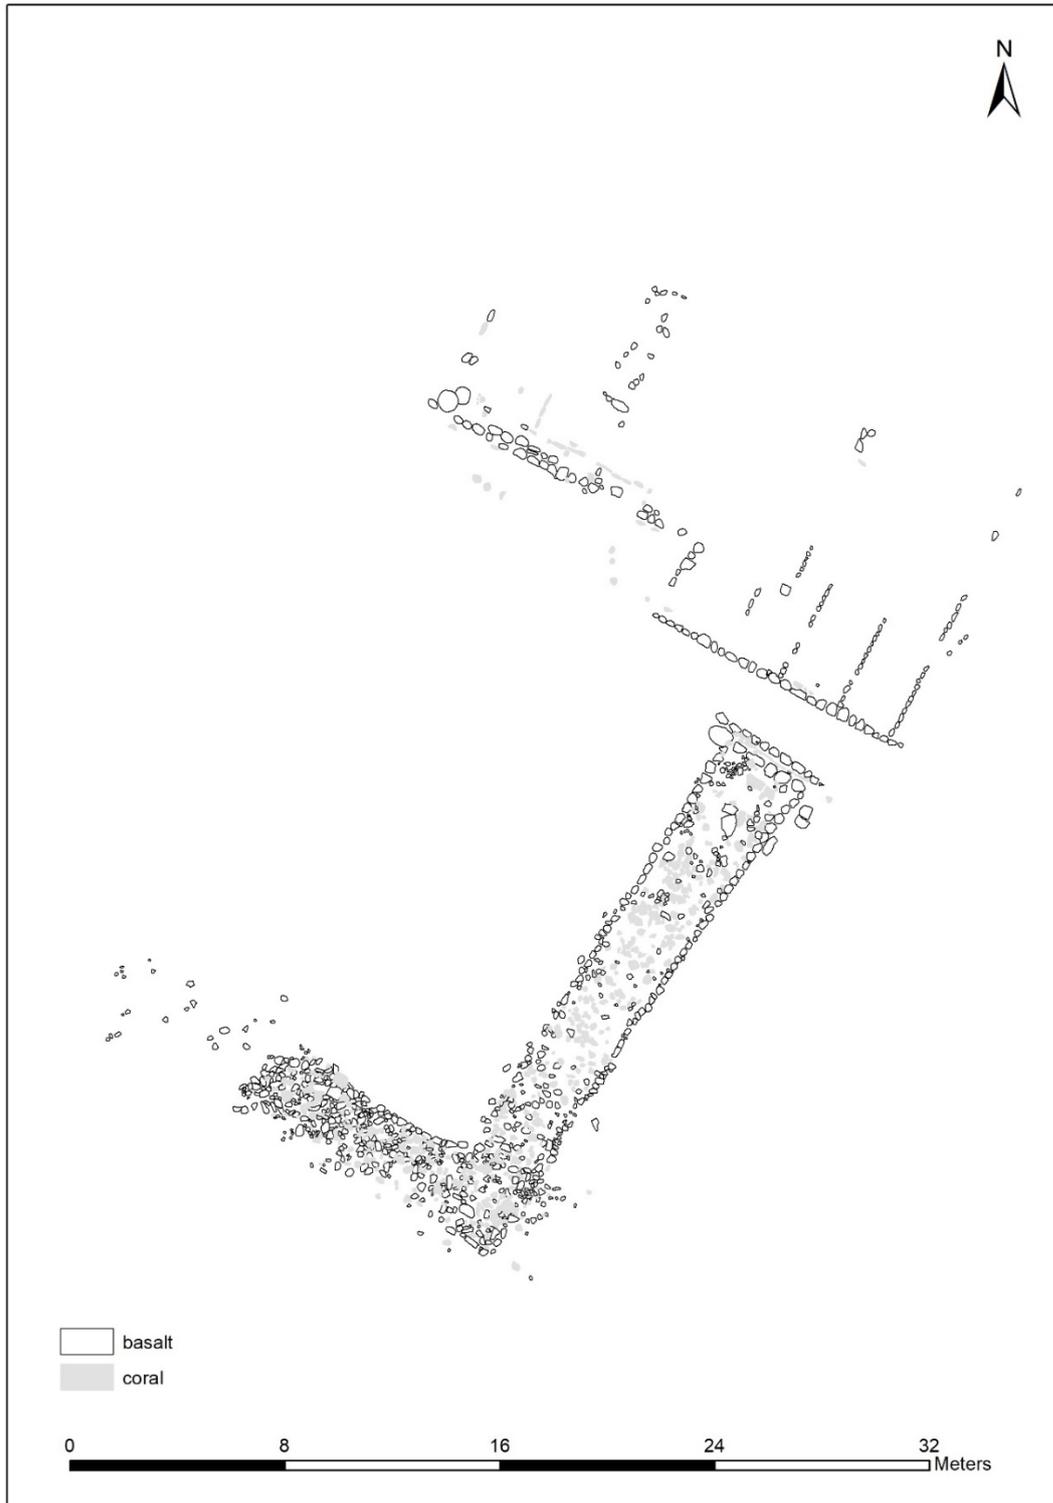
Figure 14. Composite plan showing the spatial relations between 'Are Rangi and 'Are Kariei as illustrated individually by Wilkes (1974).

On the seaward side of ‘Are Rangi was another element of the Arai te onga complex, ‘Are Kariei, known as the ‘house of amusement’ (Smith 1903, 219) (Fig. 14). In the 1960s the Canterbury expedition were able to both identify ‘Are Kariei, and create a detailed plan which also identified the location of a number of excavation trenches (Fig. 15).

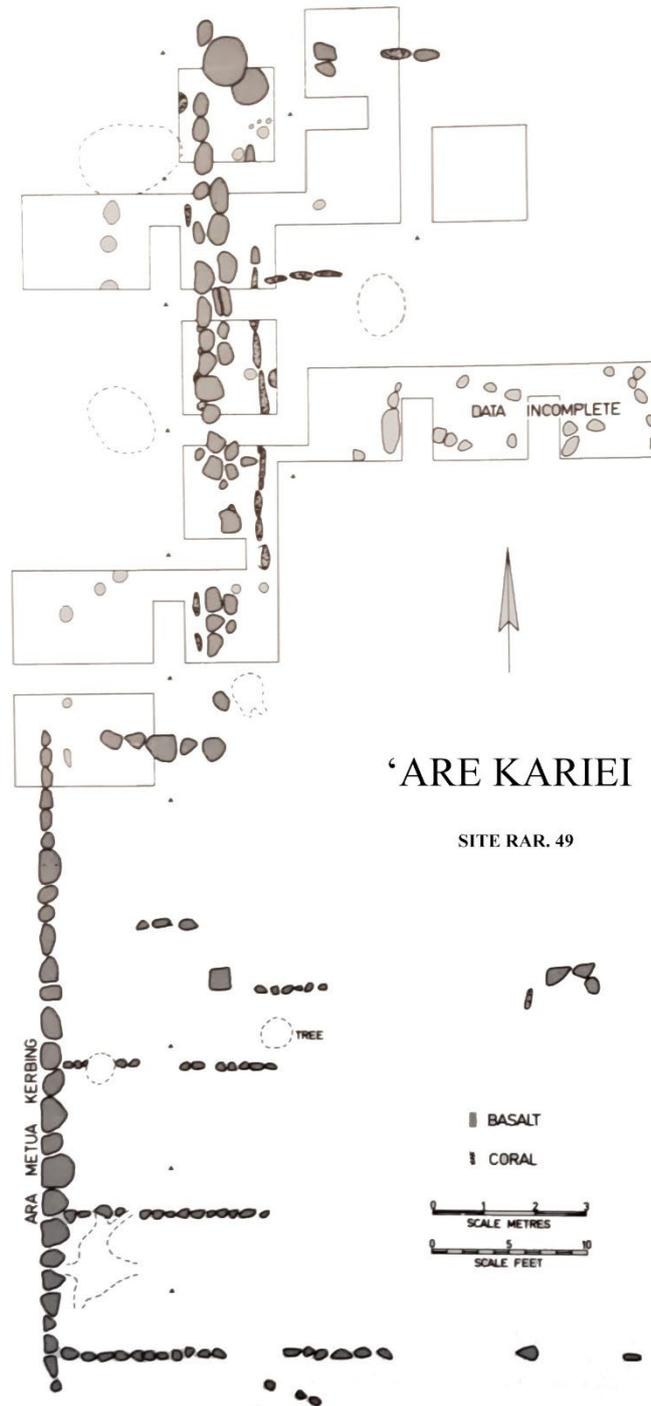
Figure 15. Detail of plan of 'Are Kariei as illustrated by Wilkes (1974, Figure 14).

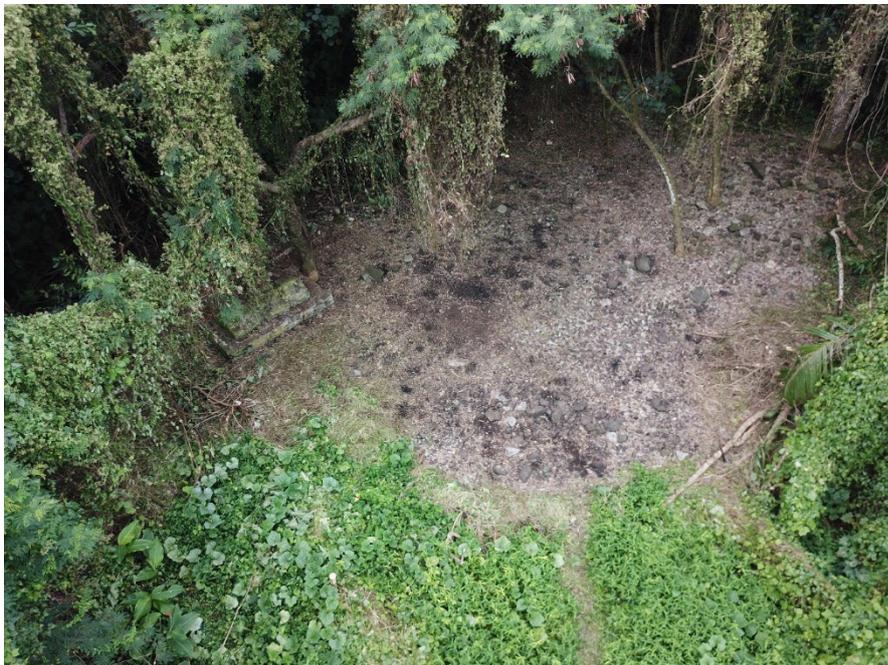
The site was partly cleared in 2019 with the assistance of missionary volunteers from the Church of Jesus Christ of Latter Day Saints. The easternmost of the coral lime graves was cleared and a wider area to the south and east, about 18 x 15m, of this grave was also cleared. This was sufficient to relocate Wilkes’ (1974: Figure 16) plan (Figs 16 & 17).

The coral lime graves remain *in situ*, though in a degraded condition, and one larger platform grave to the south of these also remains intact, but many others smaller platform / graves along with the basalt kerb of the site, as recorded by Wilkes, have been lost to, probably, pig rooting. Much of the site remains heavily overgrown and some platforms and graves may survive beneath uncleared vegetation. To the west of the coral lime graves, on the banks of the Tupapa Stream, is a more substantial stone faced and paved platform, not apparently recorded by Wilkes, roughly 500 mm high and 4 x 4 m in plan. This feature is heavily overgrown with hibiscus.

Figure 16. Aerial view of part of the Pureora site.

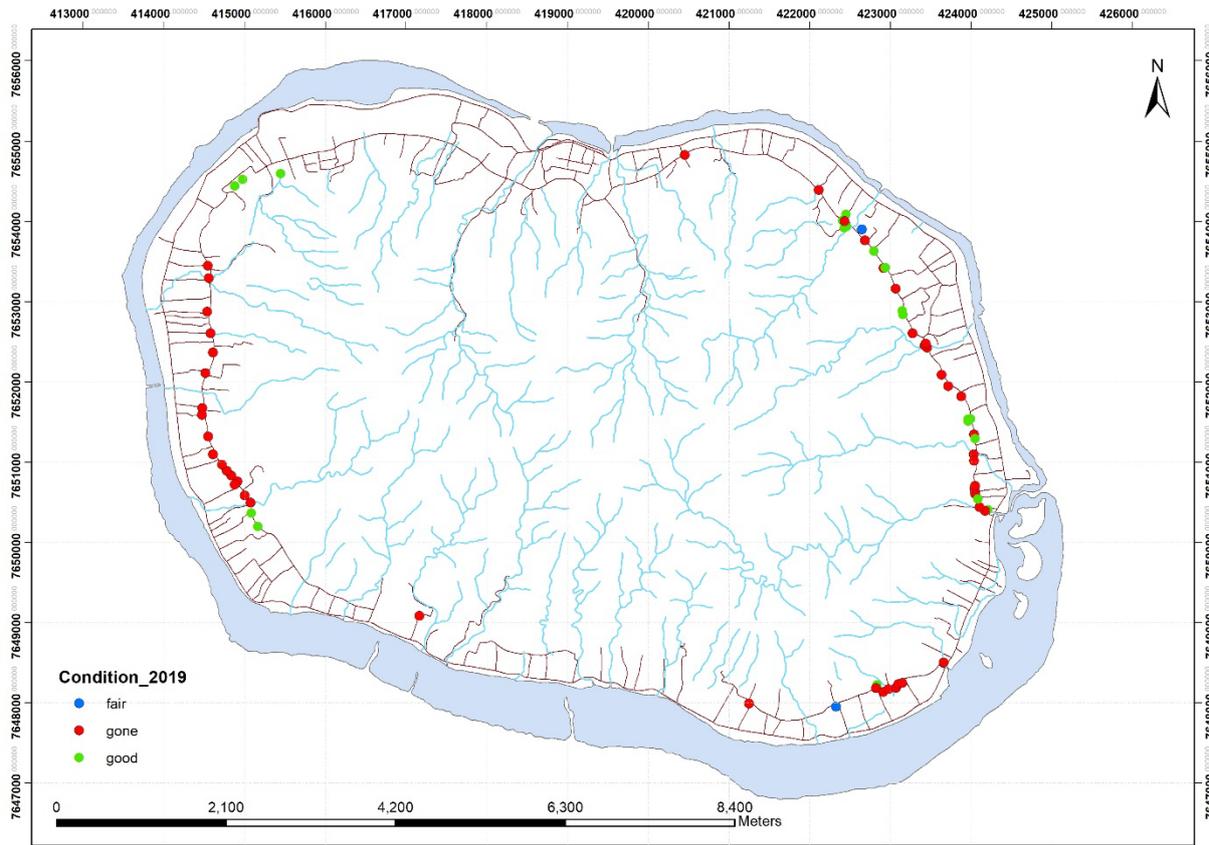
A key aim of our project, to investigate the Ara Metua in its entirety is still ongoing, however we have assessed the current survival of adjacent features since the 1960s and are therefore able to discern the rate of destruction over the last 50 years (Fig 18). At the time of the Canterbury Museum team's fieldwork in the 1960s, much of the Ara Metua was represented by three 'discontinuous sections of dirt road usable by motor traffic' (Parker 1974, 64). Consequently, far less damage had been incurred than is evident today where sections of road following the course of the Ara Metua are of upgraded metalled construction, with associated drainage ditches and services and utilities such as water and sewage pipes.

Unfortunately, a combination of these services and utilities in conjunction with house building and development has damaged and destroyed substantial numbers of sites identified in the 1960s. Three key areas where seats, paving and kerbing remain extant were identified and it is recommended these should be designated as 'protected heritage sites'.

Figure 18. Survey in 2019 showing the survival and condition of adjacent sites along the Ara Metua.
